# **OPERATING EXPERIENCE WEEKLY SUMMARY**

**Office of Nuclear and Facility Safety**

**July 30 - August 5, 1999**

**Summary 99-31**

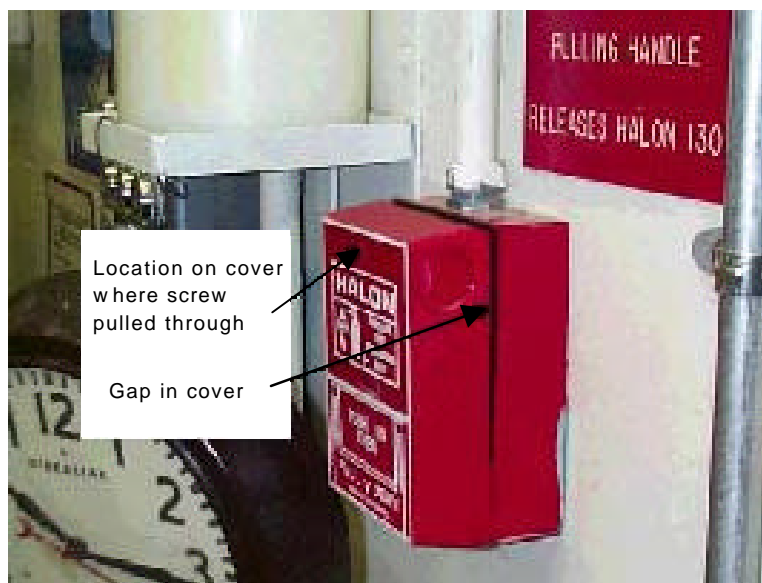
On July 29, 1999, at the Hanford Plutonium Finishing Plant, a Fire Lite Alarms, Inc. BG-10 series manual fire alarm station failed, causing alarms to sound and 340 pounds of halon to discharge into gloveboxes. Personnel evacuated the affected building. Using security cameras, personnel at the Hanford patrol central alarm saw that no fire existed in the affected area. Hanford fire department personnel, responding to the fire alarm, also determined that there was no fire. The facility manager established a fire watch for the affected area. (ORPS Report RL--PHMC-PFP-1999-0031)

The facility manager initiated a work package to troubleshoot and repair the system. Investigators discovered that a screw pulled through the plastic cover of the alarm station. This permitted the spring-loaded activation switch to push the cover away, initiating the alarm and halon discharge. Figure 1-1 shows the alarm station with the gap in the cover, as found by investigators. Figure 1-2 shows the screw that pulled through the alarm station cover and the activation switch.

Figure 1-1. Tripped Alarm Station

Investigators found three other BG-10 alarm stations that exhibited cracks in the cover at the same location. The facility manager will replace all BG-10 alarm stations with another design. OEAF engineers will continue to investigate this occurrence and will report their findings in future issues of the Weekly Summary.

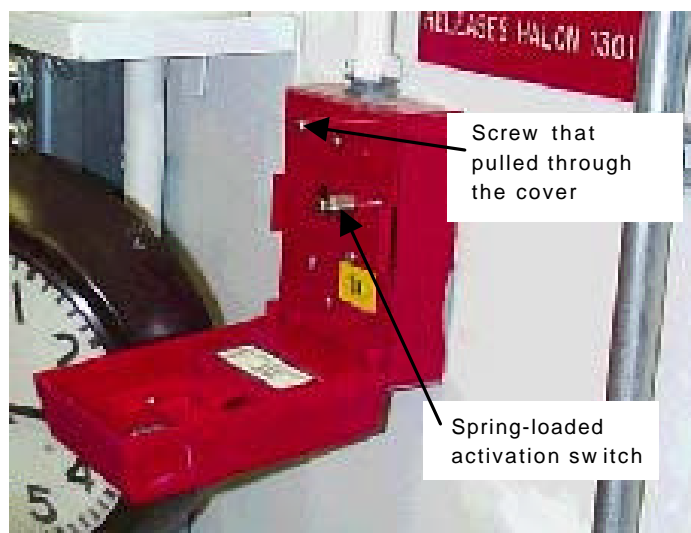
**Figure 1-2. Alarm Station Cover Screw and Activation Switch**

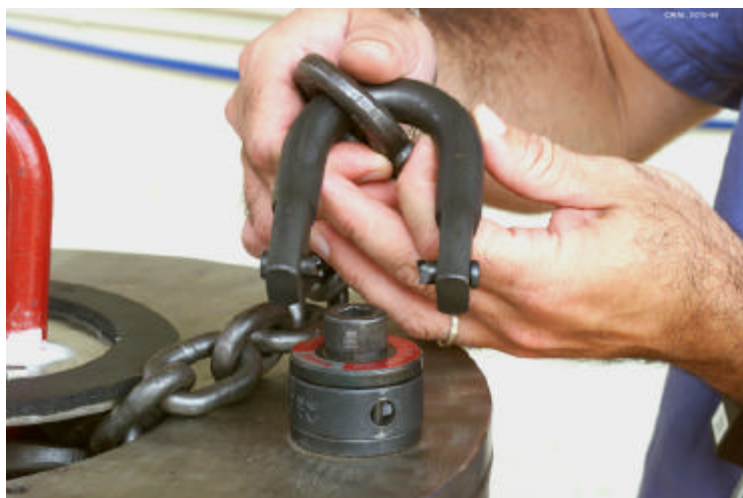
On July 27, 1999, at the Oak Ridge National Laboratory, a swivel hoist ring failed when a site rigging crew attempted to lift an empty 4,700-lb shielded cask from a truck. The cask is designed and fabricated to transport canisters of uranium-233. The swivel hoist ring, manufactured by The Crosby® Group, Inc., had a working load limit of 4,000 lb. The swivel rings had not been tested other than by the manufacturer; however, the rigging crew did inspect them visually before the attempted lift. The crew used two of the swivel hoist rings to lift the cask, and one ring failed before they lifted the cask from the truck. The rigging crew stopped the lift, and facility personnel discontinued use of Crosby® hoist rings until they determine the cause of the failure. If the hoist ring had failed after the cask left the truck, while the cask was in the air, members of the rigging crew could have been injured. (ORPS Report ORO--ORNL-X10CHEMTEC-1999-0014)

Figure 3-1 shows the Model HR125 hoist ring that failed. These swivel hoist rings are quenched and tempered alloy steel. They have a design factor of 5 to 1 and are individually proof-tested to 2.5 times the working load limit. The rings are fatigue-rated to 20,000 cycles at 1.5 times the working load limit.

**Figure 3-1. Failed Crosby® Model HR125 Swivel Hoist Ring**

Investigators determined that before this lift attempt riggers had used these swivel hoist rings more than ten times to lift and move the cask between a fabrication shop and the facility. They also determined that, since the hoist rings were last used to lift the cask, they had been used to secure the cask to the truck more than once in a manner contrary to the manufacturer's instructions. When the rigging crew used the lift rings to tie down the cask, they pulled the rings down more than 90 degrees from vertical. Investigators learned that the pivot pins on both sides of the failed lifting-ring were broken. They believe the pins may have been broken before the crew attempted the lift. Indentations on the cask from the swivel ring that did not fail indicate that the crew also inappropriately used it as a tie-down point. Investigators believe that using the hoist rings as tie-downs may have overstressed them. They are performing a metallurgical examination to determine the failure mechanism of the failed ring and will dispose of the swivel hoist ring that did not fail.

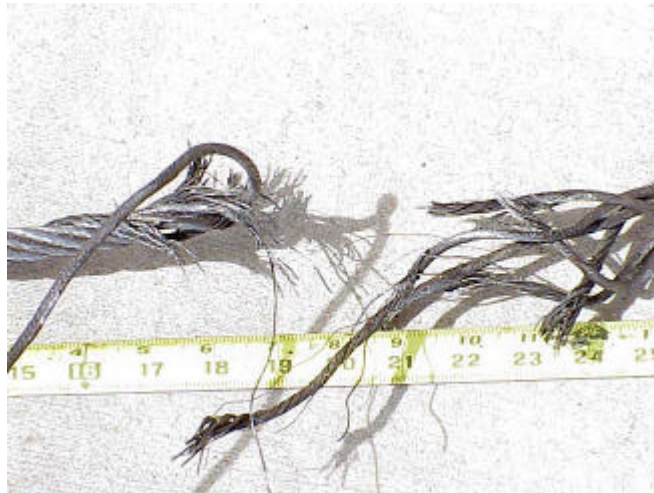
On July 29, 1999, at Sandia National Laboratory—Albuquerque, a wire-rope sling failed while a contractor was lifting a 15-ft by 25-ft door assembly. The ½-in. wire-rope sling broke into two pieces when the load was within 2 ft of its set-down location. One side of the door assembly was already on the ground, but the other side fell approximately 2 ft, damaging an electrical box and slightly bending some support framing. The sling was rated for 3,200 lb but the load weighed approximately 9,800 lb. No one was injured as a result of the sling failure. Using a sling improperly rated for the working load can result in dropped loads, equipment damage, and personnel injury. (ORPS Report ALO-KO-SNL-1000-1999-0006)

Electromagnetic Facility managers hired the contractor to move two experimental chambers from one building to another. When the door assembly for one of the chambers was ready to be moved, the contractor's riggers used their own wire-rope sling in a choker configuration to rig the load. They assumed the load weighed approximately 3,000 lb. Sandia National Laboratory provided a crane operator because Laboratory procedures prohibited the contractor from operating the crane. The riggers and crane operator visually inspected the sling and determined it was in good working condition. The crane operator asked about using a synthetic sling, but the contractor was worried because the load had sharp edges. There was no tag on the sling indicating its working load limit, so the operator asked if the sling was capable of lifting the load. When the contractor assured the operator that the sling was adequate, the crane operator lifted the load and moved it with the crane until the sling failed. Figure 5-1 shows a close up of the failed wire-rope sling.

**Figure 5-1. Failed Wire-Rope Sling**

After the load dropped, the contractor stopped the work and notified a safety engineer. The safety engineer responded to the scene and requested that crane maintenance personnel inspect the crane before resuming any lifting operations. The inspectors determined that the crane was not damaged and placed it back in service. The safety engineer met with all involved parties to discuss responsibilities for making future lifts associated with this project.

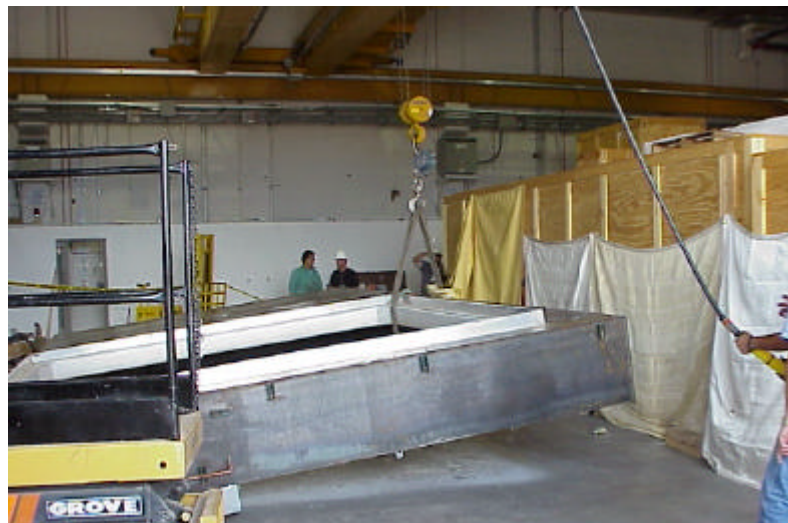
Investigators learned that the fabricator of the door assembly indicated that it weighed 5,200 lb. Figure 5-2 shows the door assembly. However, using a load cell, a crane inspector determined the actual as-built weight of the door assembly was approximately 9,800 lb. This weight was well within the 10-ton working load limit of the crane. Investigators have not yet determined how the contractor arrived at their 3,000-lb estimate for the load.

**Figure 5-2. Door Assembly**

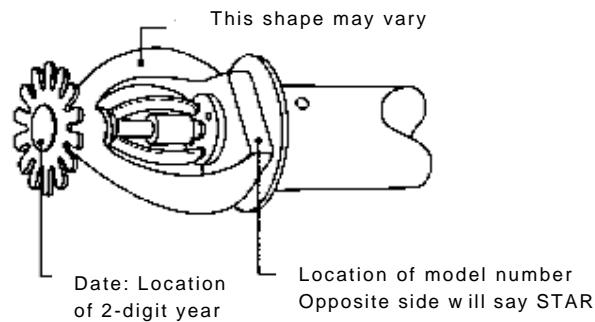
On August 4, 1999, Mealane Corporation, in cooperation with the Consumer Product Safety Commission (CPSC), announced the recall of approximately 1 million Star brand fire sprinklers. These sprinklers could fail to activate during a fire, resulting in facility damage, financial loss, and personnel injury or death. Star sprinklers have been installed nationwide in nursing homes, hospitals, schools, resorts, stores, office buildings, warehouses, and supermarkets. The recall is limited to Star sprinkler dry-pipe models D-1, RD-1, RE-1, E-1, and ME-1, manufactured from 1961 through 1976. The name "Star" appears on the sprinkler along with the model number and date of manufacture. Figure 7-1 and 7-2 are diagrams illustrating the Star brand sprinkler and the associated markings .

**Figure 7-1. View of Pendent and Upright of Star Brand Sprinkler**

CPSC reported that 67 percent of the Star sprinklers submitted for testing to independent laboratories failed to activate as they should. CPSC also said they received one report concerning a Star sprinkler that allegedly did not activate during a bedroom fire in a nursing home.

Facility managers should determine whether their facilities contain these recalled sprinklers, and, if so, call the Star sprinkler recall hotline at 800-866-7807 or access the recall web site at [www.star-recall.com](http://www.star-recall.com). Mealane Corporation will provide free replacement sprinkler heads and reimbursement for the labor costs of removing and replacing the recalled units. A CPSC press release and more recall information, including the diagrams of a Star sprinkler showing locations of identifying marks, are available at <http://www.cpsc.gov/cpsc/pub/prerel/prhtml99/99152.html>.

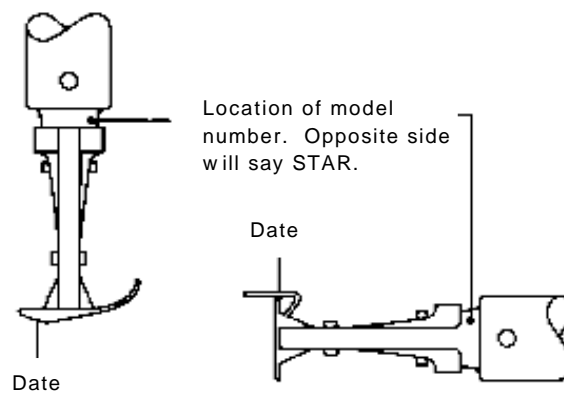
**Figure 7-2. View of Vertical and Horizontal Sidewalls of Star Brand Sprinkler**
